# Sky View window

Important operational safety advice relating to your Swift Fiat Motorhome Sky View Window.

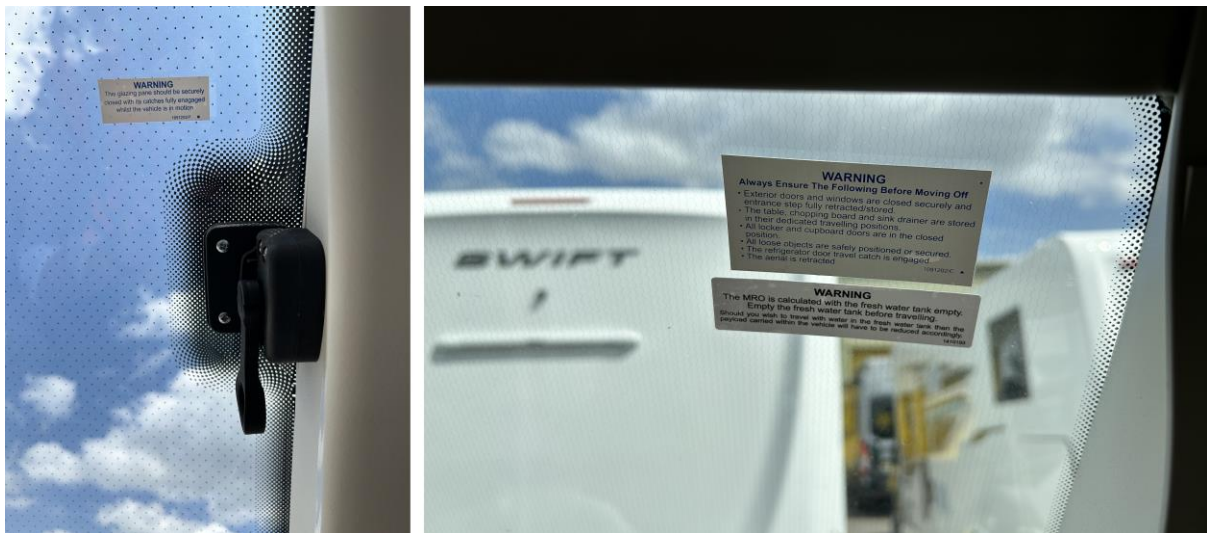
**This window is not designed to be used unsecured / open when the motorhome is being driven under any circumstances.**

This has been advised in the user handbook and also using advice labels on the window itself and the cab windscreen. Examples of the advice labels are provided below.

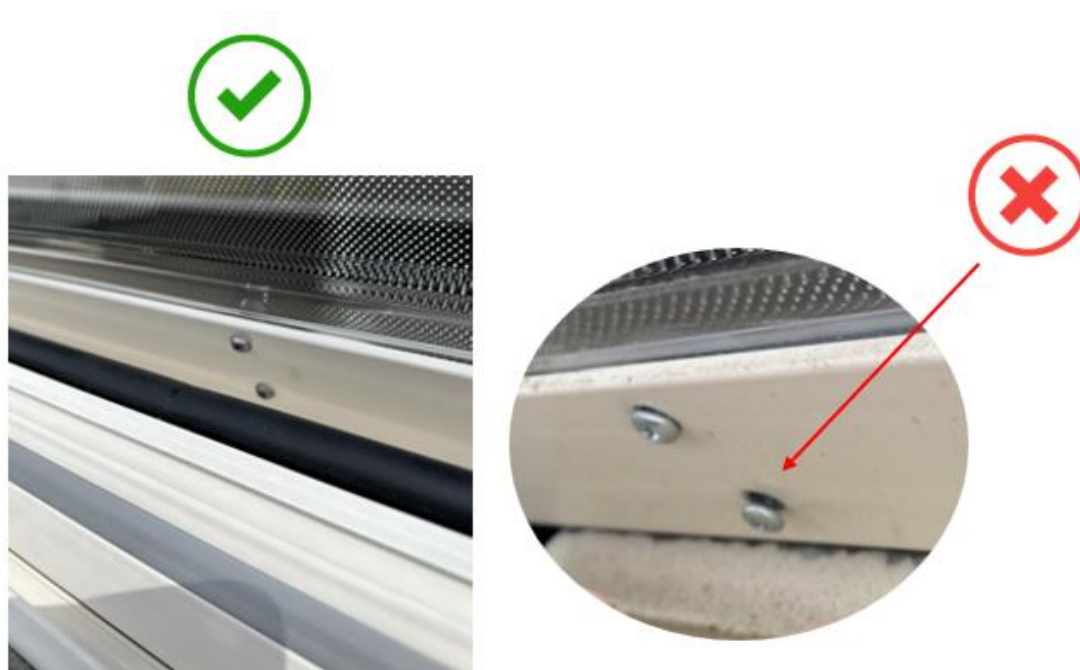
We have recently investigated several instances of failures relating to this window assembly and extensive testing undertaken by the supplier of the window system and independent test experts have determined that the cause of failure is that customers have accidentally, or otherwise, driven the vehicle with the window in an unsecured position and this has placed additional stresses on the window and its fixings.

- 1) Unsecure the window catches
- 2) Open the window to the maximum position the mechanism will permit
- 3) Inspect the six screws are present on the lower window hinge profile and that they appear to be fully secured in place i.e. the base of the screw head is flat on the profile and no screw thread is visible under the head.

Figure 2 - Example of unsecured lower screw fixing with a loosened (lower) screw

If, upon inspection, screws are missing or in an unsecured state then please contact a Swift Approved workshop or any AWS approved workshop that can rectify this issue quickly with a Fixing Kit, please note this will be on a chargeable basis.

have the window inspected and rectify where necessary by a Swift Approved workshop or any AWS approved workshop. Second or subsequent owners of vehicles shall also need to have this check undertaken to ensure that previous owners had adhered to the guidance on usage.
